DEEP-OCEAN BIODETERIORATION
OF MATERIALS — PART VI. ONE
YEAR AT 2,370 FEET

U. S. NAVAL CIVIL ENGINEERING LABORATORY
Port Hueneme, California

Technical Report R-525

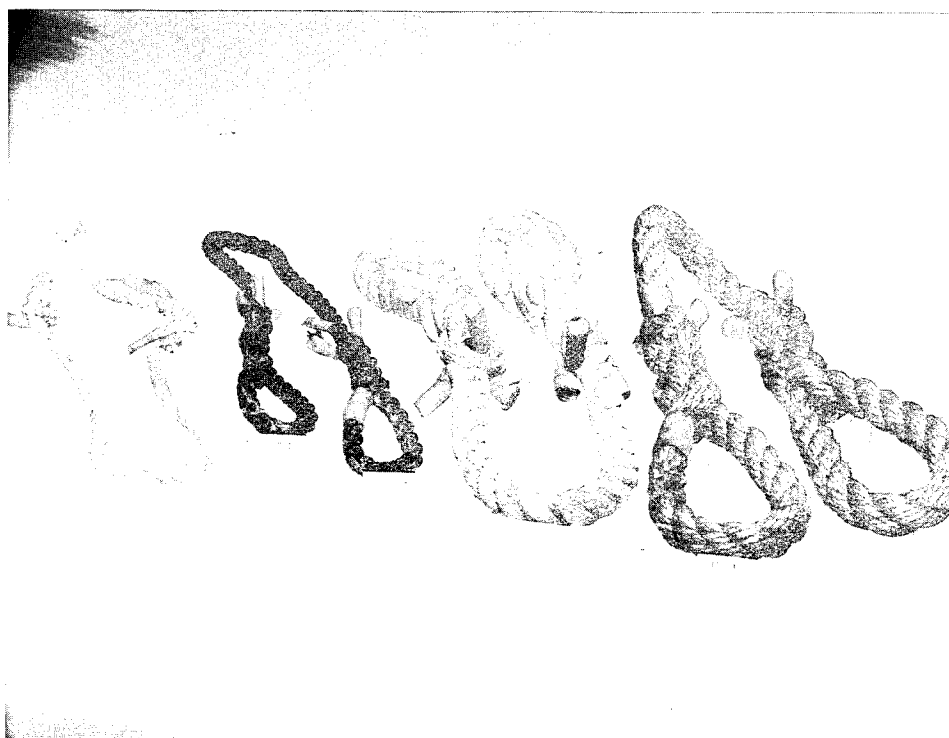
Figure 42. Rope specimens which were placed inside a plastic test chamber.

Generally, the materials placed in the plastic tube were not deteriorated as severely as those materials exposed outside the tube (Figure 42). The fir panel was moderately attacked by borers, with some borers measuring about 1/4 inch in diameter. The fibers of cotton and manila rope specimens were slightly deteriorated by micro-organisms. Borers were not found in manila rope specimens. The synthetic rope specimens were in excellent condition. The various electrical cable insulations (15 mils thick) on No. 16 wire were not affected. However, a large section of the white polyvinyl chloride insulation had turned black after being exposed to the hydrogen sulfide in the mud (Figure 43). This change occurred probably because there may have been small quantities of lead in the PVC insulation, and this lead had reacted with hydrogen sulfide to form lead sulfide, which is black. Small test strips of white polyvinyl chloride materials such as this could probably be used to detect the presence of hydrogen sulfide in an anaerobic environment, especially in areas where conventional testing devices cannot be placed or used for detecting hydrogen sulfide.
